*International workshop on Paleoseismology, Active Tectonics and  
Archaeoseismology*

# Following the historical traces of the 1909 Lambesc earthquake

*Field trip guide - 26 & 30 sept. 2022*

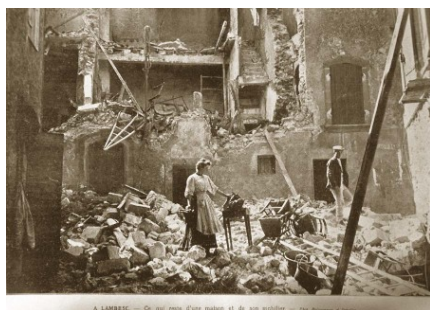
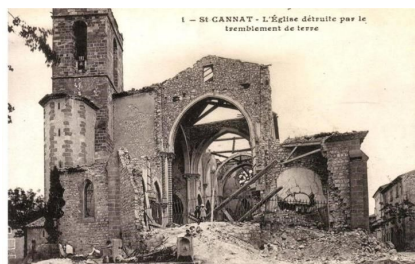
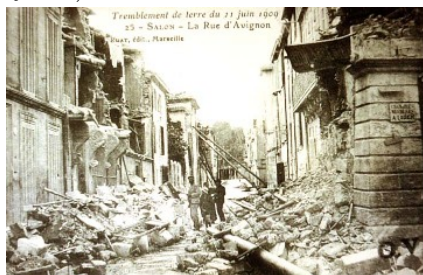
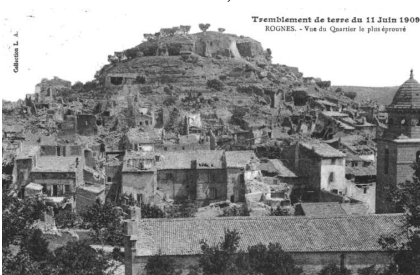
Figure 1: Postcards created from photographs of damage in the devastated villages.

(a) Lambesc (Source: planet-terre.ens-lyon.fr)

(b) Saint-Cannat (Source: tourism offices of Saint-Cannat)

(c) Salon-de-Provence (Source: tourism offices of Saint-Cannat)

(d) Rognes (Source: Les Amis du Patrimoine de Rognes)

Many villages, such as Vernègues, Pelissanes, Rognes, Lambesc, Puy-Sainte-Réparate, Venelles, and Salon-de-Provence were devastated. Although the earthquake caused death, the number of destroyed houses suggests that the human toll could have been higher. Fortunately, many people were outside during the main shock and not in their homes. According to a Rogne's resident:

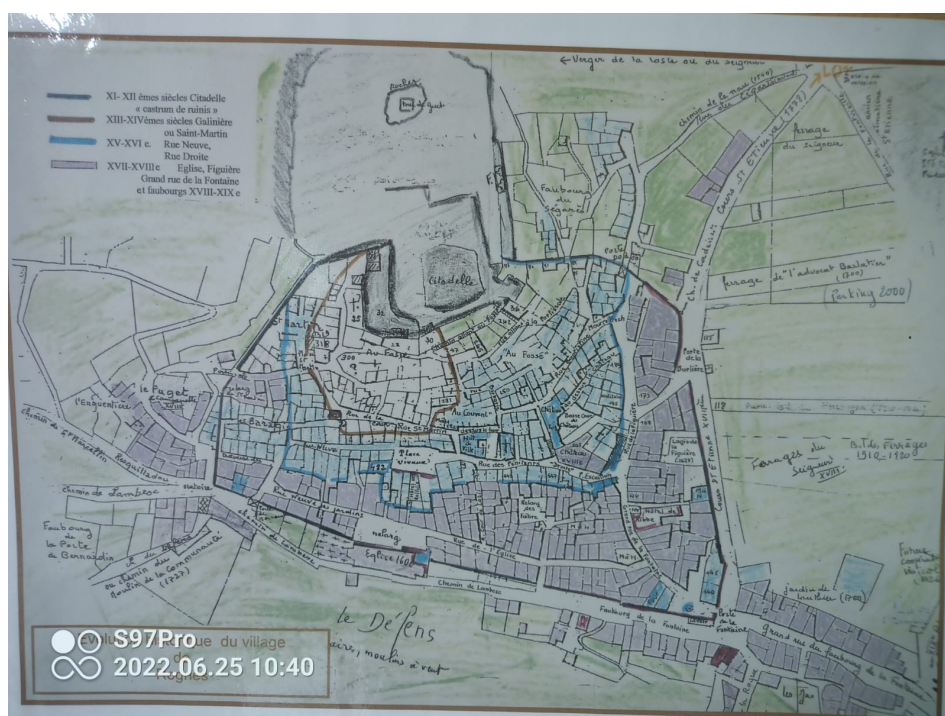
Figure 7: Historical evolution of the village of Rognes plotted on a map from 1837. Grey: district built in XI-IIth century ("castrum de ruinis"). Brown: district built in XIII-XIVth century. Blue: district built in XV-XVIth century. Pink: district built in XVII-XVIIIth century. Source: "Les Amis du Patrimoine de Rognes".

The village of Rognes has crossed the centuries. *Rongnis, Ruinis, Rognos, Rougnès, Rognes*, its name has also changed many times. The heights of Rognes were occupied during the neolithic and the Iron Age. During the Middle Ages, the "Foussa" plateau was a strategic place. The plateau is located at an altitude of more than 800 m. It was the birthplace of the village of Rognes. The "Castrum de Ruinis" was extended during the medieval period. The etymology of Rognes probably comes from the remains of previous occupations. As for "Foussa," the ancient cadastres reveal that this toponym (quite paradoxical for a summit since "Foussa" means "gap" in Provençal), will only appear in the 17th century, after the dismantling of the citadel of which only the filled-in gap remained in the classical period. In the 13th century, a still visible defensive wall embanked the Galinière and the Saint-Martin sector. The troubles of the XVIth century (wars of religion and wars of Italy) led to the eviction of a defensive wall about 800 m, seven towers, and

three doors. The fortress became a power position. In 1595, Rognes hosted the Duke of Epernon's cannons against the people of Aix rallied to Henri IV. This event led to the dismantling of the fortress between 1597 and 1600. Before the 1909 earthquake, some of the houses in Rognes date back to at least the 11th century (Fig. 7). The construction techniques used, the ageing of the materials implies an important vulnerability of the buildings.

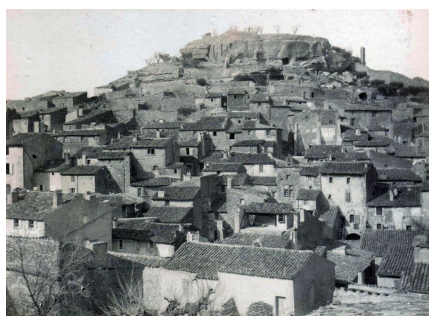
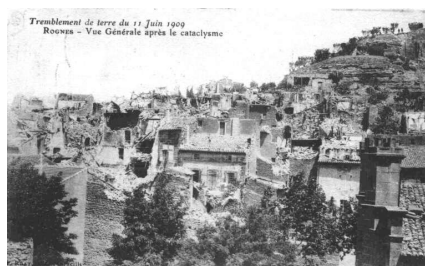
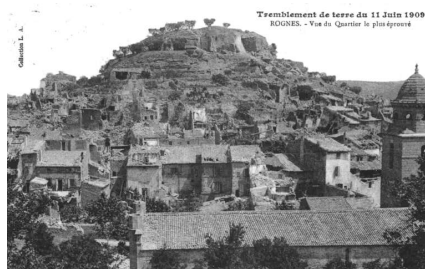
Figure 8: Postcards created from photographs of damage in the devastated Rognes.

(a) View from the Defens in 1905.

(b) View of the west district.

(c) View from the Defens.

(d) View from the Defens on the most damaged district.

In 1909, the village of Rognes was located on the side of the Foussa (Fig. 8a). The Provencal earthquake totally destroyed the houses surrounding the summit (Fig. 8b, 8c, 8d). Only a wall from the beginning of the XVIIth century is still standing. The houses located at the foot of the hill suffered less. Today the houses built on the slopes are modern, while those at the foot are traditional.

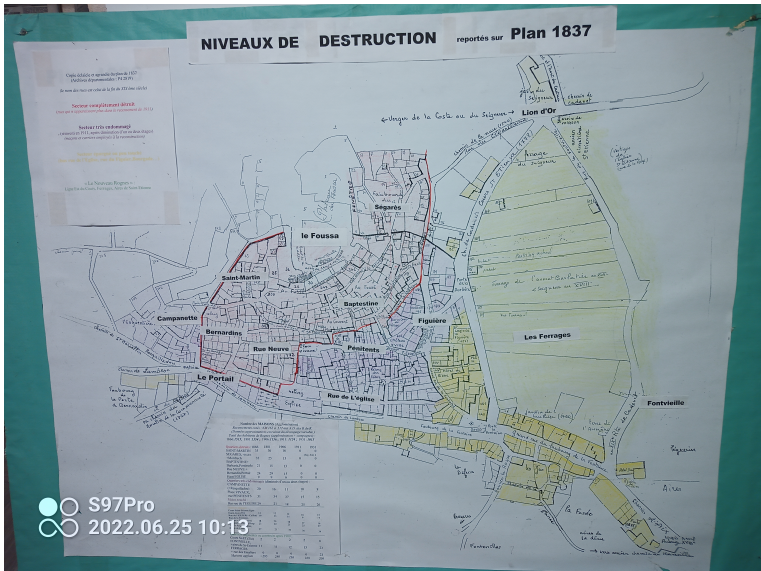
Figure 9: Distribution of the damage during the 1909 earthquake reported on a map of 1837. Red: destroyed. Purple: highly damaged. Yellow: Slightly damage. Green: rebuilt district after the 1909 earthquake. Source: "Les Amis du Patrimoine de Rognes", archives départementales: P4 2819.

Fig. 9 shows more precisely the distribution of the damage around Rognes reported on a map of 1837 (before the earthquake). The houses surrounding the "Foussa" were almost destroyed (in red). The second belt suffered significant damages (destruction of roof, in-plan mechanisms). The houses far from the "Foussa" were more spared (yellow).

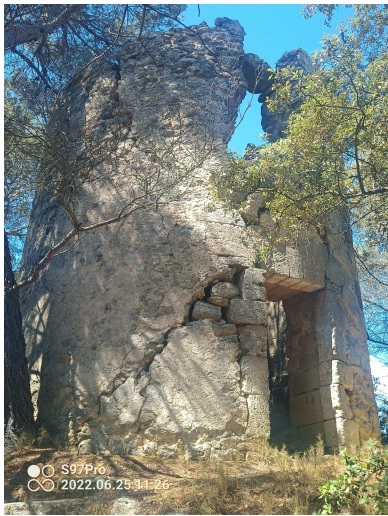
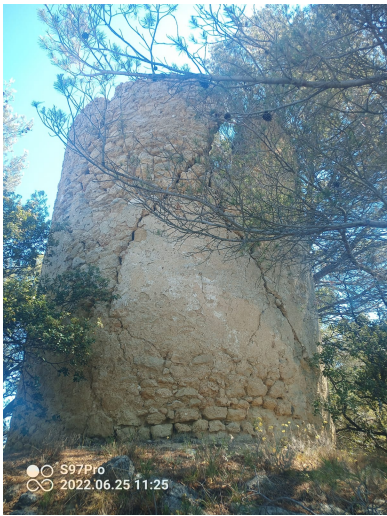
Figure 12: Photos of the Défens windmill.

(a) Windmill of the Défens district.

(b) Windmill of the Défens district.

Before going back down to the village to have a closer look at the buildings, let's observe a vestige that has well known the earthquake of 1909. Many windmills were built in the area of Rognes (Fig; 11). Most of them were already abandoned at the beginning of the 20th century. We will stop in front of one of the mills of Le Défens (Fig. 12a-12b).

The damage observed is typical of the damage caused in Rognes during the earthquake. The wall of the windmill highlights in-plane failure mechanisms (Fig. 13) which is typical of the response of a cylindrical structure (strong wall cohesion).

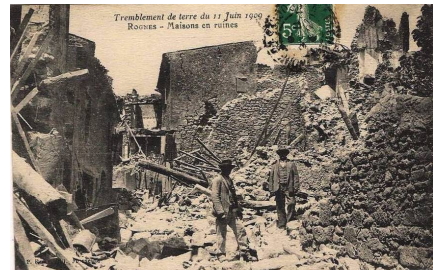
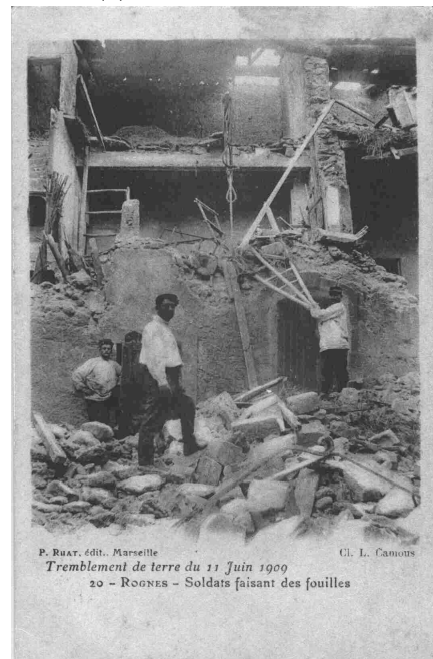
Figure 14: Postcards created from photographs of damage in the devastated Rognes.

(a) Collapsed buildings in the northern district of Rognes.

(b) Collapsed buildings.

(c) "Rue du Chateau".

(d) Soldiers doing researches.

Looking at the photographs of the damaged building, you can identify the classic mechanisms of collapse (Fig. 13). Some streets of Rognes are almost destroyed (Fig; 14a- 14b). The buildings built in the outer part of Rognes are less damaged

(Fig; 14c). After the disaster, three companies of the 55th army came to help the rescuers (Fig. 14d).
